# **Bat Potential Roosting Feature Assessment**

**Waterside Club, Coracle Way,  
Carmarthen, Carmarthenshire**

**Final Report**

**March 2025**

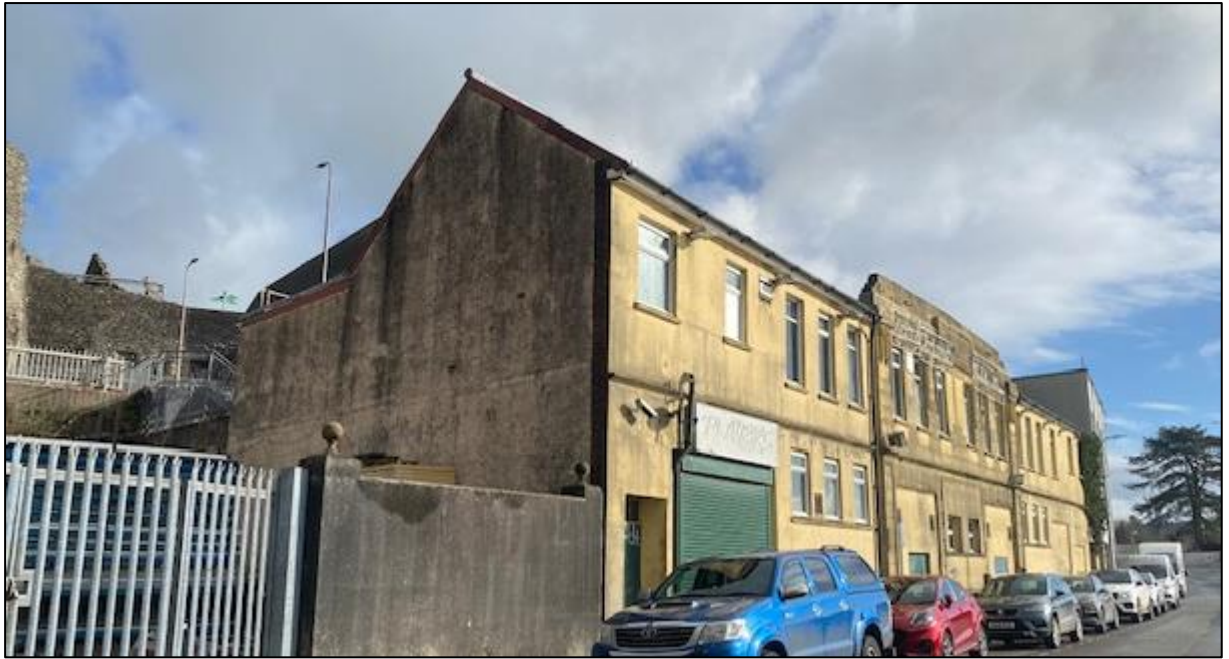
Figure 2. Southern and western elevations.

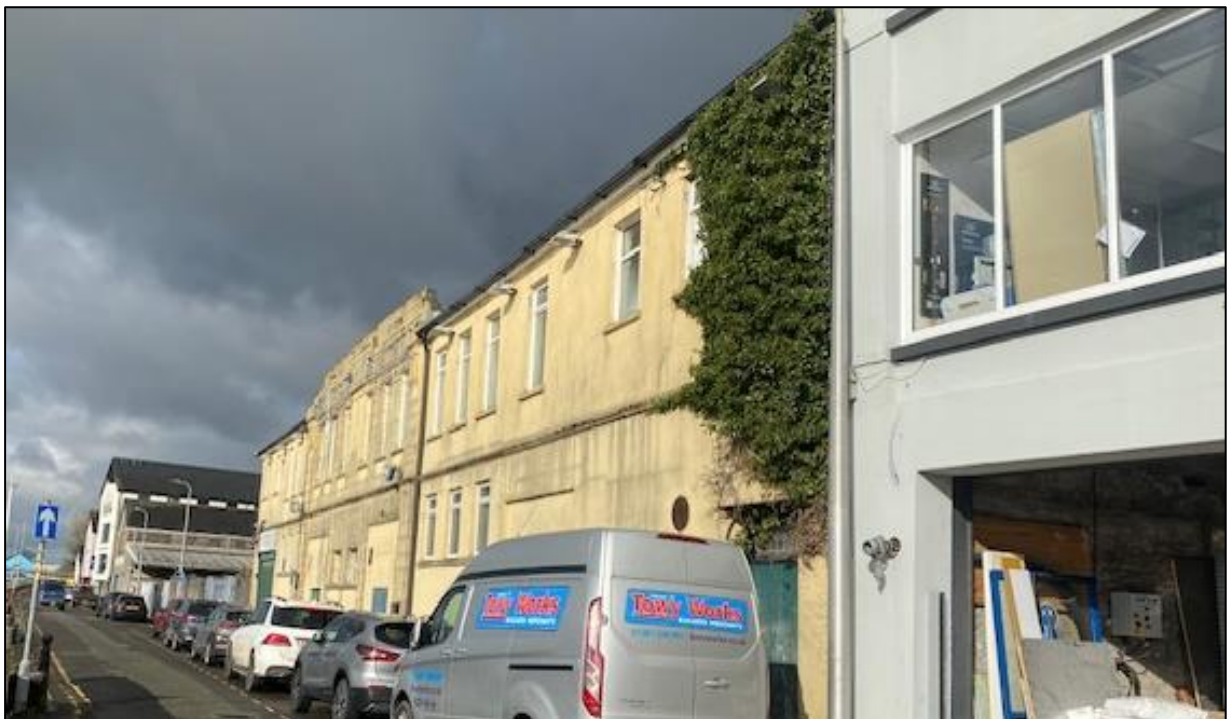
Figure 3. Southern and eastern elevations.

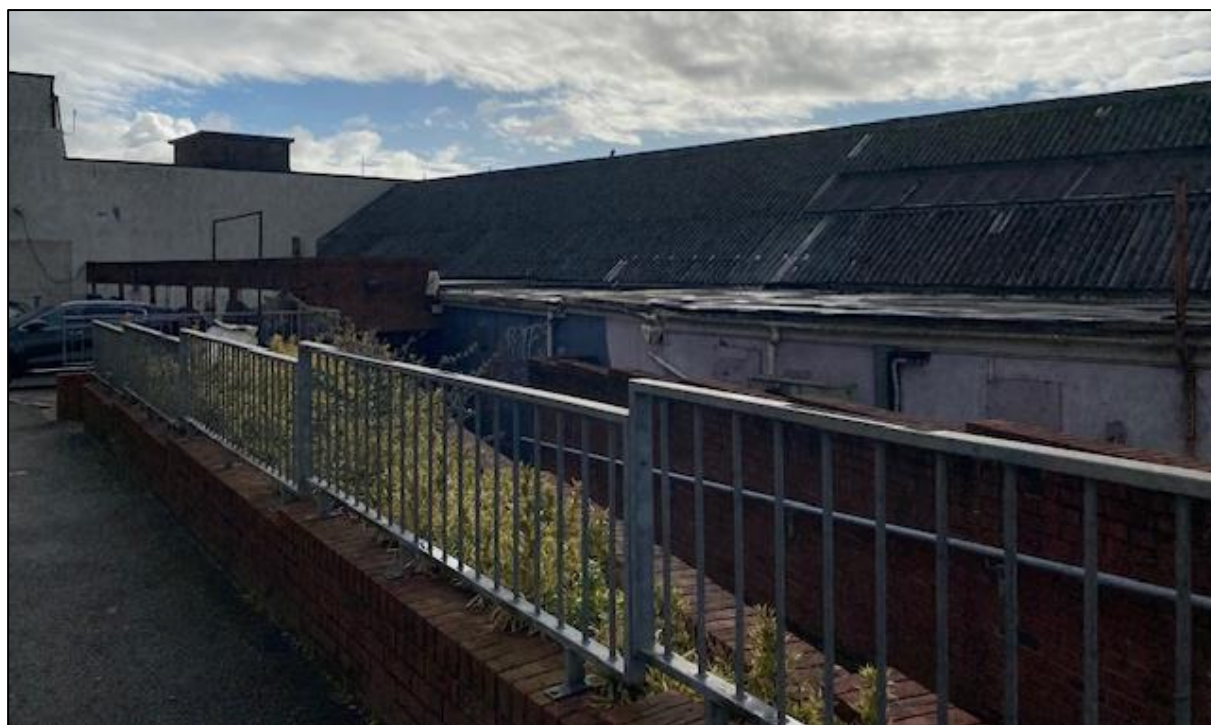
Figure 4. Northern elevation.
