# 48 STATION ROAD, PORT TALBOT PRELIMINARY ROOST ASSESSMENT FOR BATS

Date: **September 2025**

| <b>TITLE:</b> | Preliminary Roost Assessment for Bats |

| <b>REPORT No.:</b> | 348-02-01.R2 |

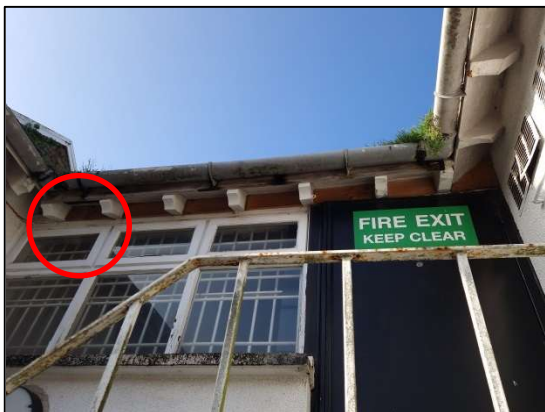
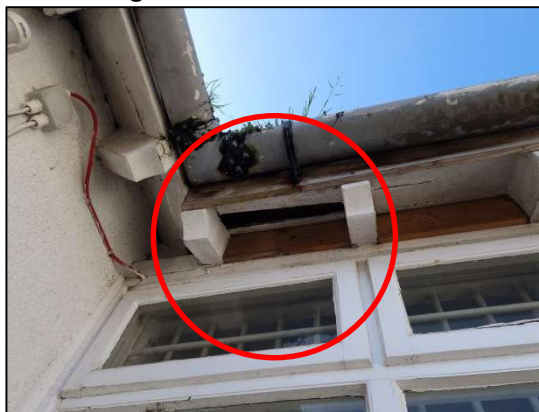
**Figure 8 – Damage to Wooden Soffit Recorded at Rear (E) Side of Building, in Corner of Southernmost Gable**

**Figure 9 – Closer View of Damage to Wooden Soffit Recorded at Rear (E) Side of Building**

As discussed, a hole of approximate 30cm x 10cm size was present within the underside of the soffit toward the eastern side of the building (as Visible in Figures 8 & 9)

This hole was surveyed thoroughly, and upon inspection it could be seen that the hole is superficial in nature, providing no access to further areas of the property interior. A small void is present in this location, however upon thorough inspection; no evidence of bat usage was recorded around or within the damaged soffit.

A small area of damage to a timber soffit of approximate 30cm x 10cm size was recorded on the underside of the soffit toward the eastern side of the building beneath the southern gable. This hole was surveyed thoroughly, and upon inspection it could be seen that the hole is superficial in nature, providing no access to further areas of the property interior.

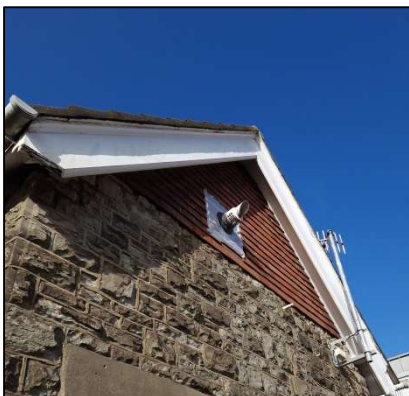
Although the gables are constructed from the same stone as the rest of the building, a vertical / hanging tile finish is located toward the top of the gables at each end of the building. The hanging slates were found to be in excellent condition, (with no significant areas of damage which may be suitable for crevice-dwelling bats) being recorded. Furthermore, no gaps were recorded behind the wooden fascia boards and the vertical / hanging tiles which make up the finish of the gable ends in this location.

**Figure 10 – Hanging Tiles in Good Condition at Apex of Northern Gable at Rear (E) Side of Building**

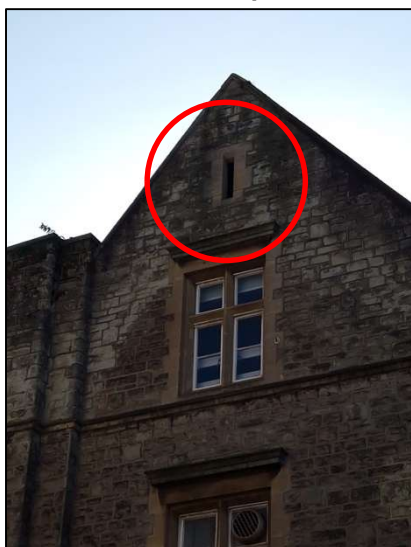
It should be noted however that a small arrow loop style slit window was also observed at the apex of the northern wall of the building. From the building exterior, it appears as though this gap may permit potential access to an interior loft-space, which may be present above the 2<sup>nd</sup> floor of the building.

**Figure 11 – Slit Window on (N) Wall, which may Permit Access to an Interior Loft Space**

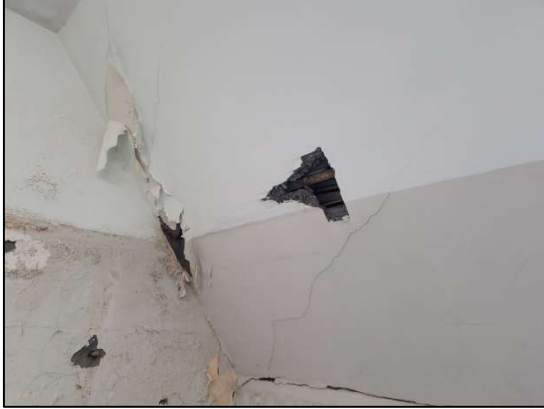
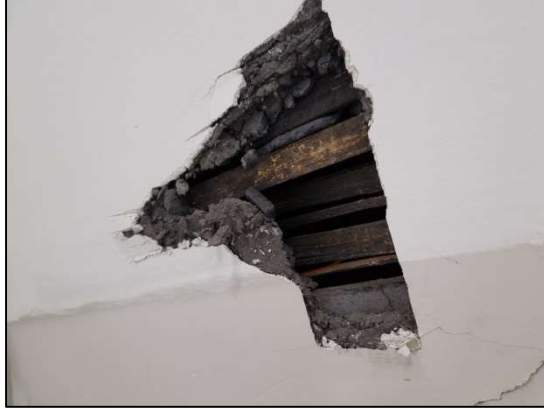
**Figure 23 – Damage to Plasterboard Making up Ceiling of 2<sup>nd</sup> Floor Room, Exposing Timber Framework Beneath**

**Figure 24 – Closer View of Damage to Plasterboard Making up Ceiling of 2<sup>nd</sup> Floor Room, beneath which Timber Framework Making up the Underside of the Roof is exposed**

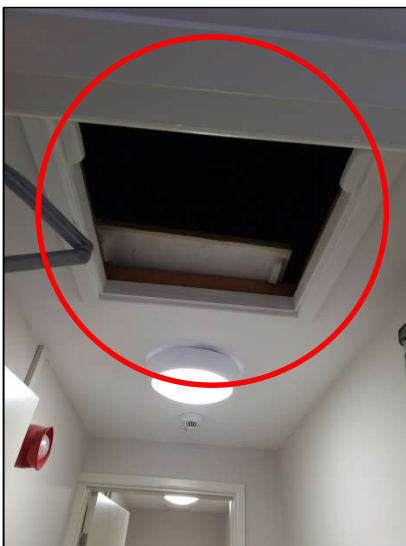
**Figure 25 – Access to Void via Hatch in Ground Floor Ceiling**

A small hatch is present within the ceiling toward the eastern extremity of the ground floor (as visible in Figure 25). The hatch was accessed via ladder, and upon entry a small void was observed. This void is well insulated, and appears to house a number of electrical cables and water pipes, which likely serve the ground floor toilets located below.

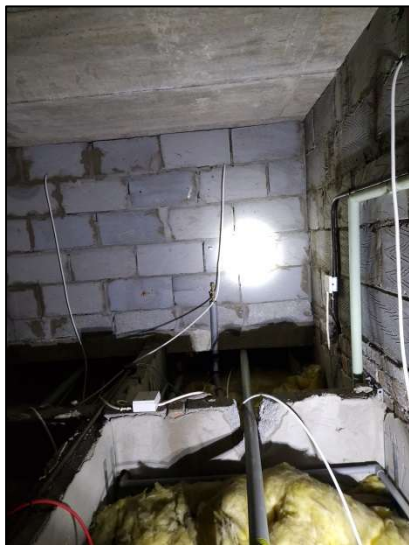
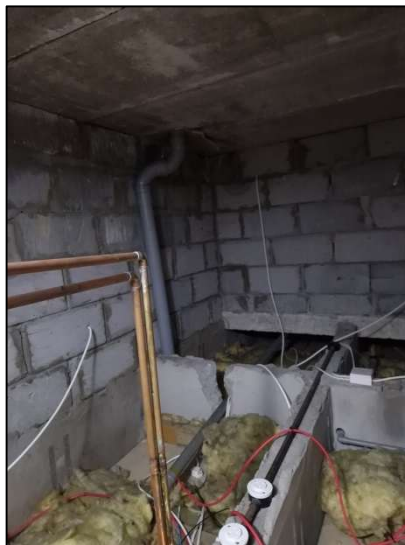
The floor and ceiling of the void are constructed from concrete, whilst tightly-fitted concrete blocks make up the walls. No light egress into this void was observed, suggesting that there are no access or egress points into this void apart from via the access hatch present within the ground floor ceiling.

**Figure 28 – Interior Details of Void on Ground Floor**

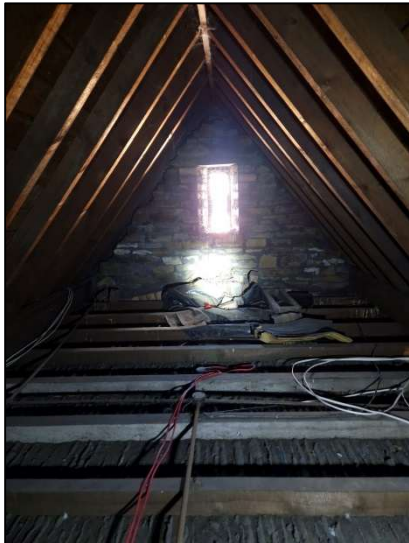
**Figure 30 – Light Ingress from Arrow Loop Window at (N) End of Main Building Loft**

The northern section of the loft was significantly lighter than that of the southern section. This is due to light ingress being observed from the northern end of the loft, whereby the arrow loop style window observed from the building exterior allowed a substantial amount of light to enter the northern side.

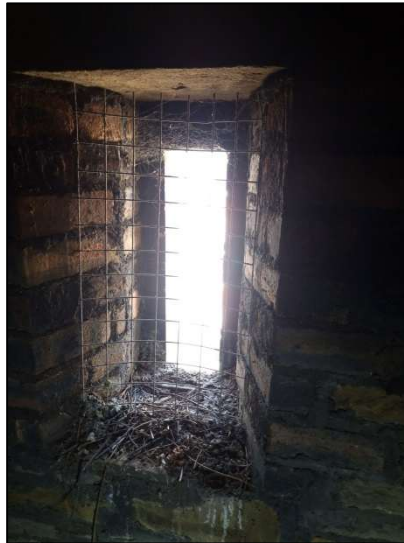
**Figure 31 – Arrow Loop Window Detail, with Mesh Covering. Historical Bird Nest can be seen**

The window was inspected in detail, and upon closer inspection, it appears as though a mesh frame has been placed across the window, likely in order to deter nesting birds (evidence of nesting birds was found throughout the loft, with broken eggshells and disused nests being identified in close proximity to the window and along the small wall in the northern section of the loft) from entering the loft.

It should however be noted that, although the gaps within the mesh were considered to be potentially adequately sized to enable access/egress for bats to the main building loft interior, no evidence of historical or active use of the loft by bats was identified after an extensive inspection of the loft which was undertaken during the Preliminary Roost Assessment.

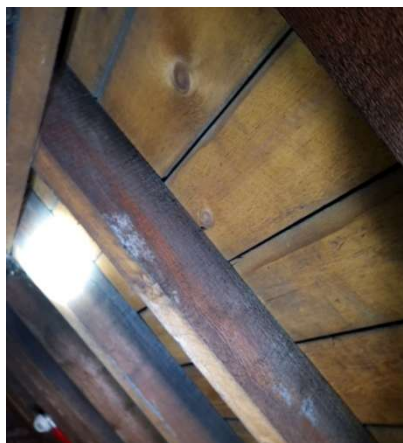
Tightly sealed and adjoined timber boards were visible to be present underneath the double Roman roof tiles of the exterior leaving none of the tiles exposed or visible from the interior of the building. Given that these boards are located beneath the exterior double Roman tiles which make up the roof, there is the potential for a small void to be located between the wooden panelling and the roof tiles making up the roof itself.

It should be noted however that no gaps were identified within or between these timber boards from the loft interior. Furthermore, no damage was recorded to the structure of the roof from the building exterior, whereby the double Roman tiles were found to be in excellent condition, with no damage (such as from lifting, slipping or cracking of the tiles) being recorded. As such, no potential access/egress points for bats to the building interior

**Figure 34 – Tightly-Sealed Timber Boards Located Under Double Roman Roof Tiles**

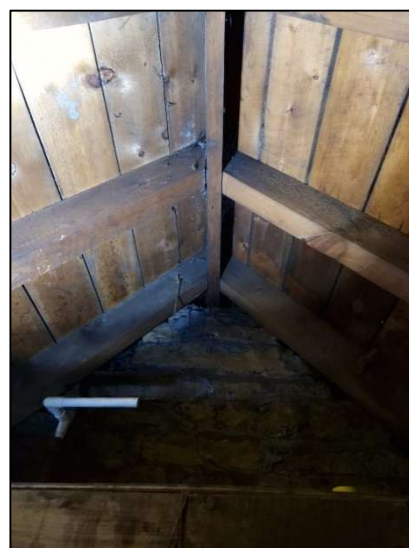
**Figure 38 – Tightly Sealed Timber Boards in 2<sup>nd</sup> Loft**

The interior of the northern gable loft is similar to that of the main building loft, with the exterior double Roman tiles being shielded from view by tightly fitted timber boards which have been set on the rafters of the loft in this location.
