# Combined Arboricultural Impact Assessment/ Method Statement Land between A40 and Railway Carmarthen SA31 3RB

**Conducted By: Ben Clark TechArborA**

**08/02/24**

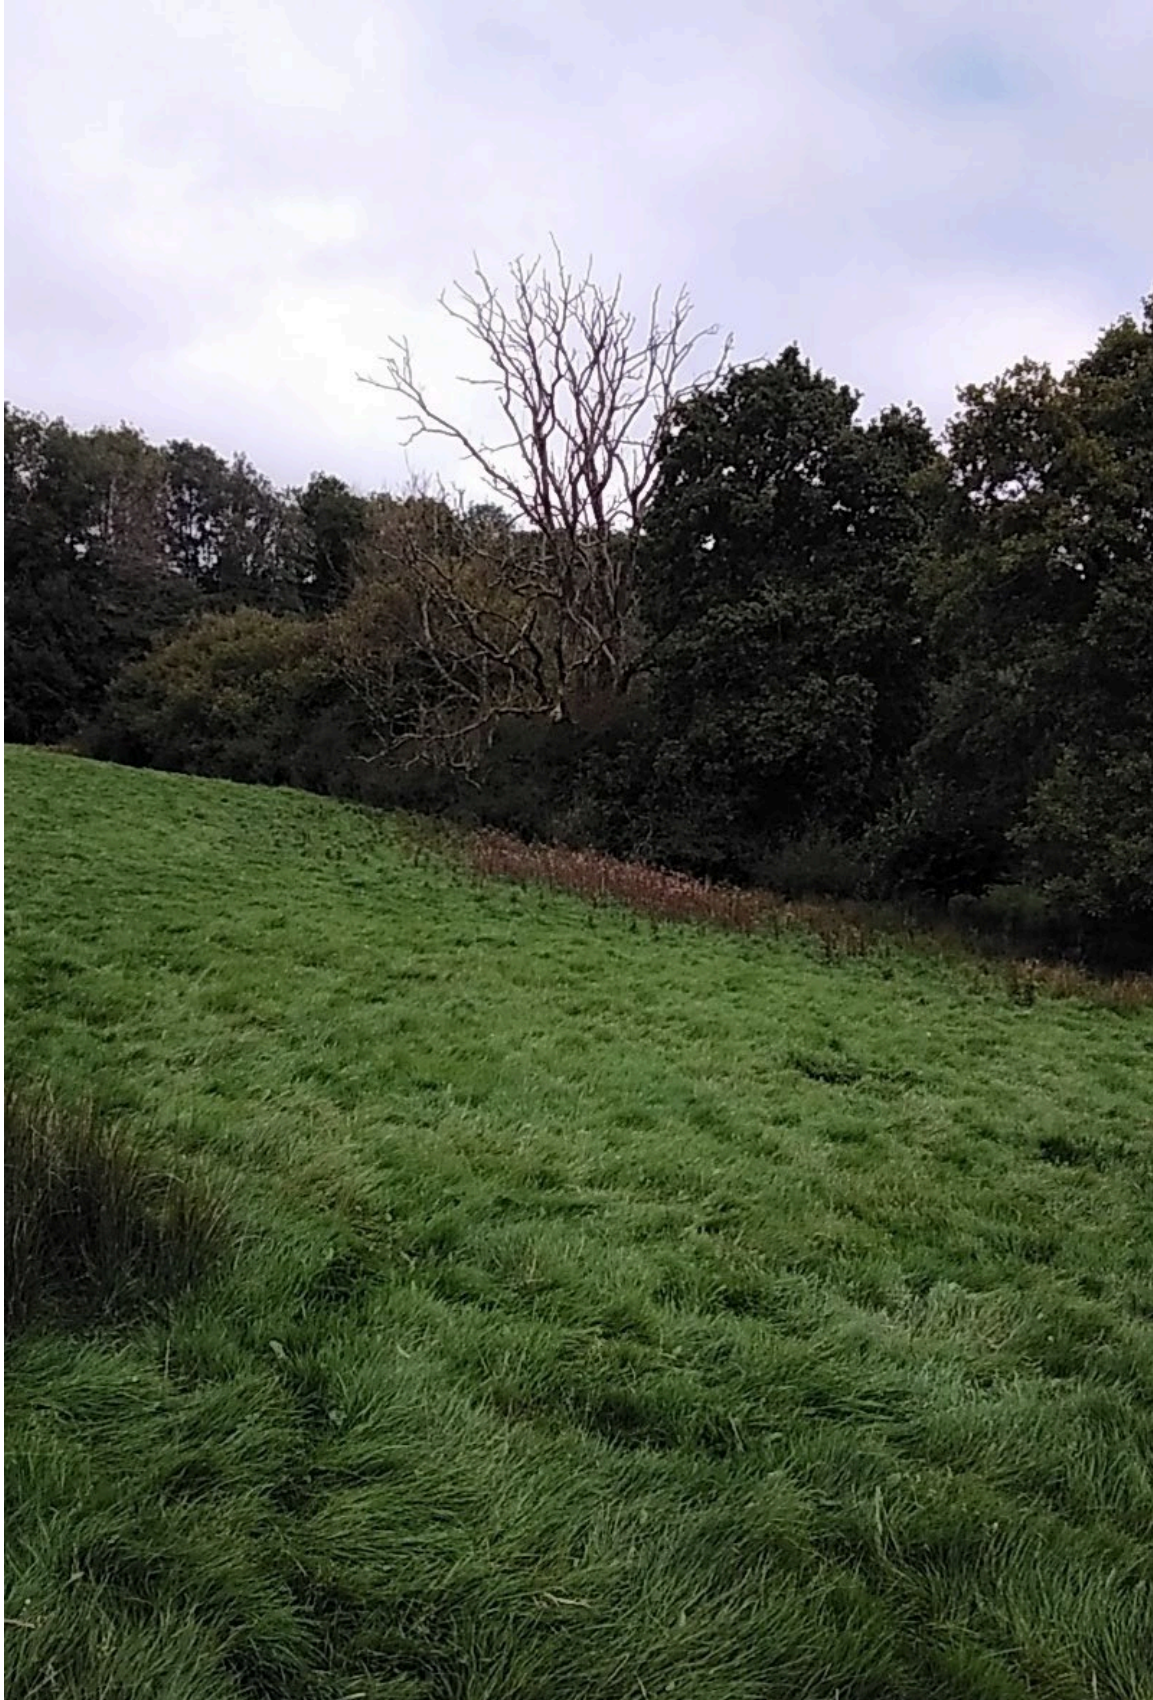
**Photo I:** [T21](#) Dead Ash tree.

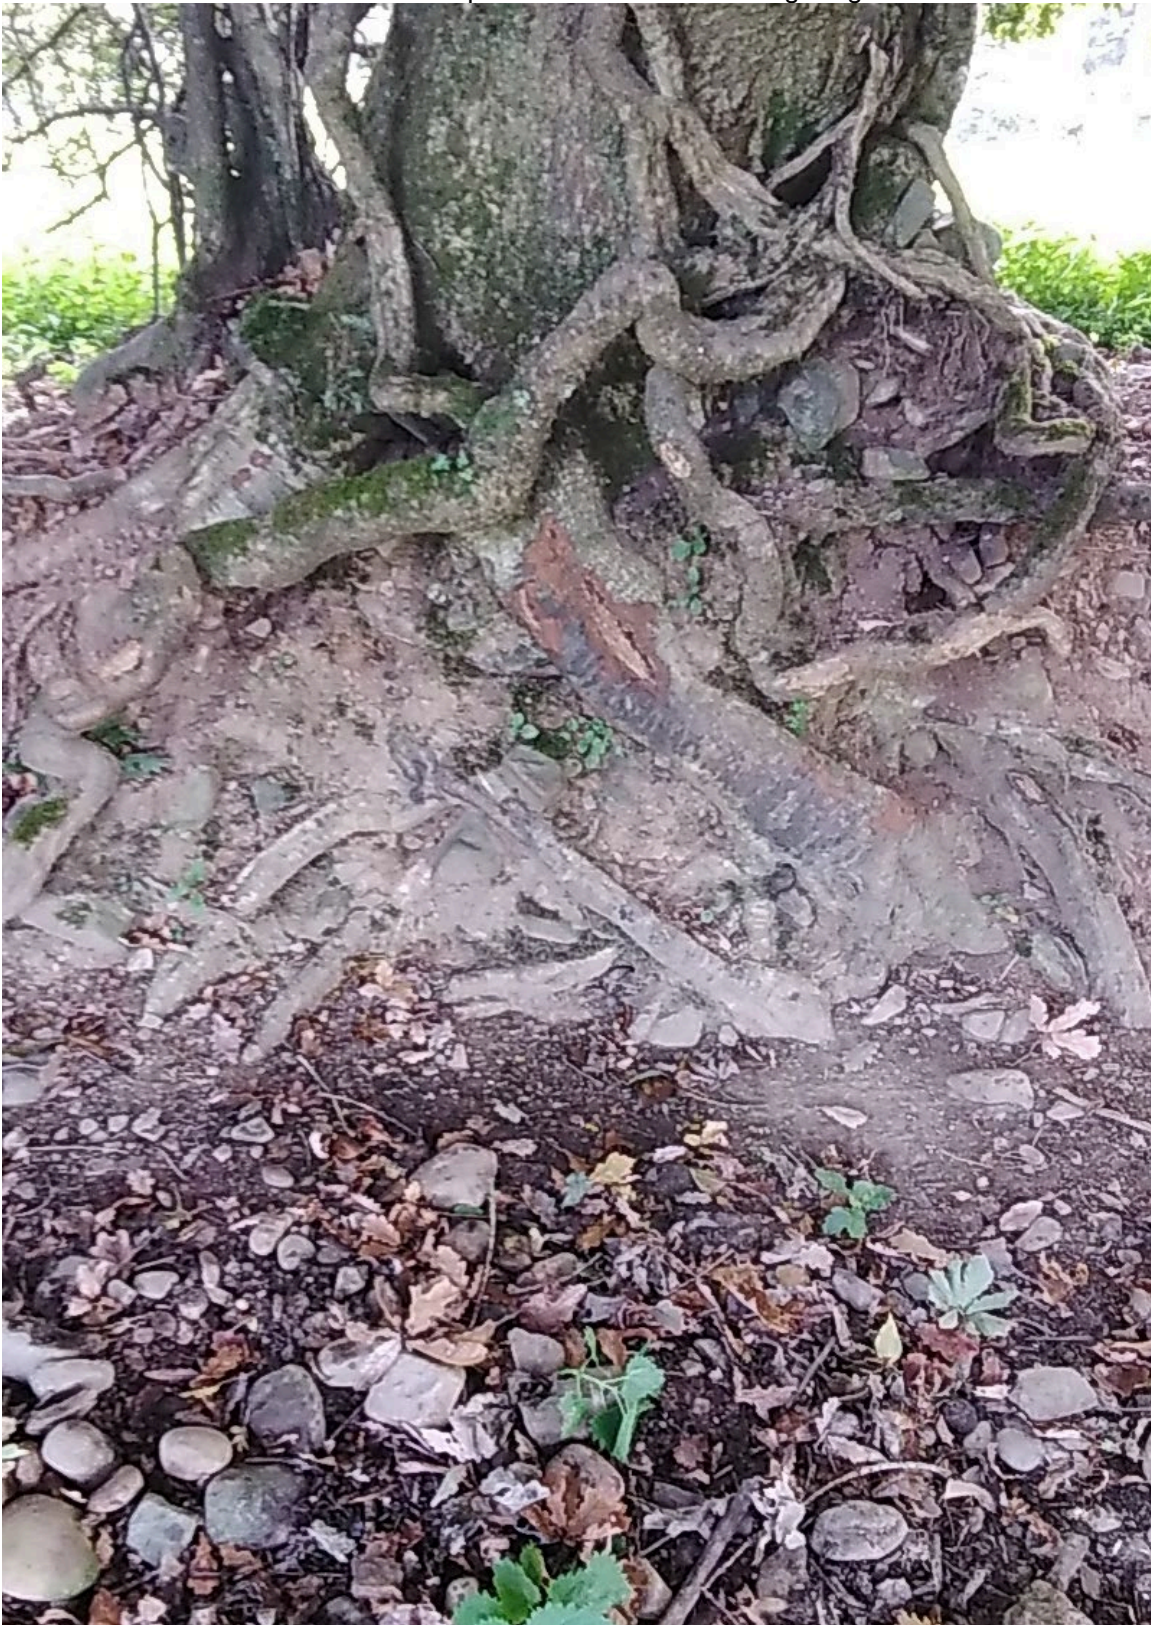
| Ref | Tag | Species | Height (m) | Stem Diameter (mm) | Crown Spread (m) | | | | Crown Clearance (m) | Lowest Branch (m) | Survey Notes | Recommendations | Life Stage | Life Expectancy (years) | Retention Category | RPA Area (m <sup>2</sup> ) | RPA Radius (m) | Photo |
|---|---|---|---|---|---|---|---|---|---|---|---|---|---|---|---|---|---|---|
| | | | | | | | | | | | with exposed surface roots around the base likely due to livestock, leaving exposed roots. | soil improvement over the rooting area to improve long term viability. Carry out 3m crown reduction to prevent damage during works. | | | | | | |

**Photo 2:** [T3](#) Exposed roots due to livestock grazing.
