**Tree Check**  
Arboriculture Ltd.

# Tree Survey and Categorisation Land between A40 and Railway Carmarthen SA31 3RB

**21/09/23**

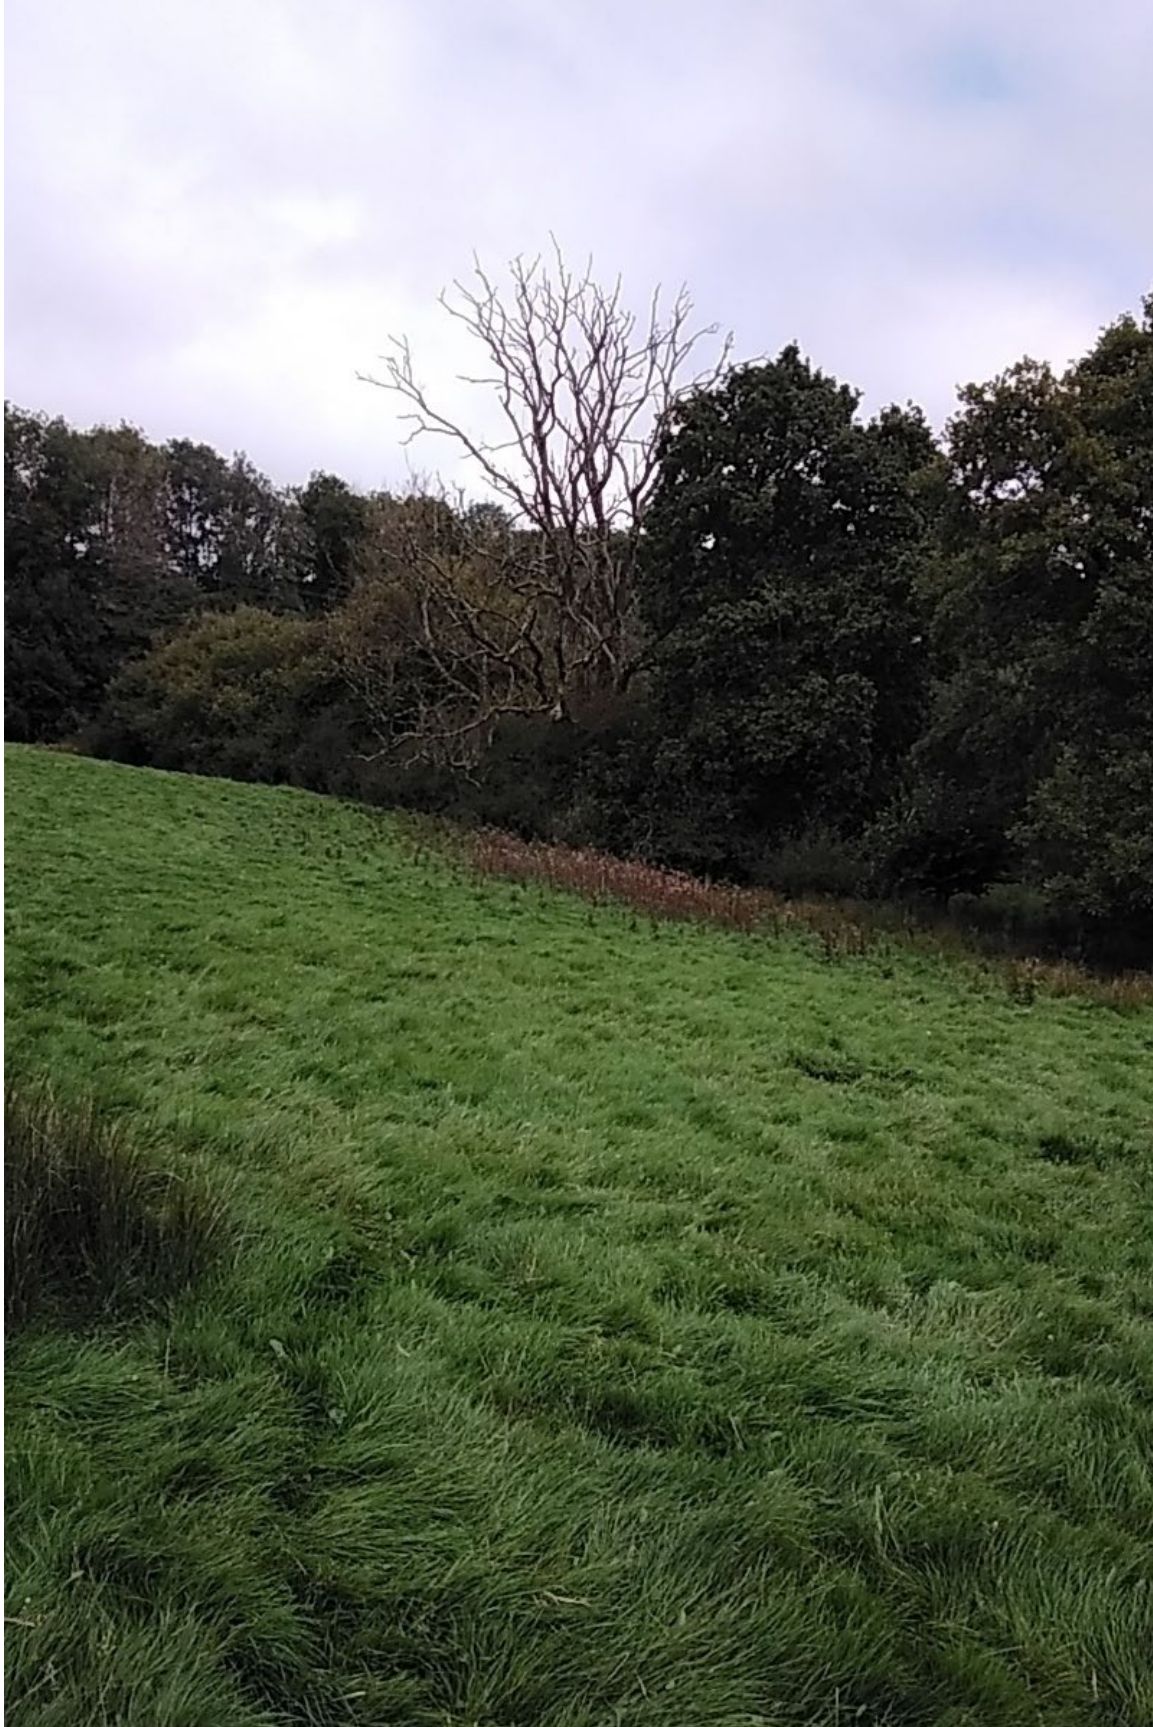
**Photo I: T21 Dead Ash tree.**

- Category U Trees should be removed before work begins on site.
- The trees or groups with reference numbers: T16, T17, T18, T19, T20, T21 are considered unsafe and recommended remedial work should be considered a top priority, regardless of the progression of development.

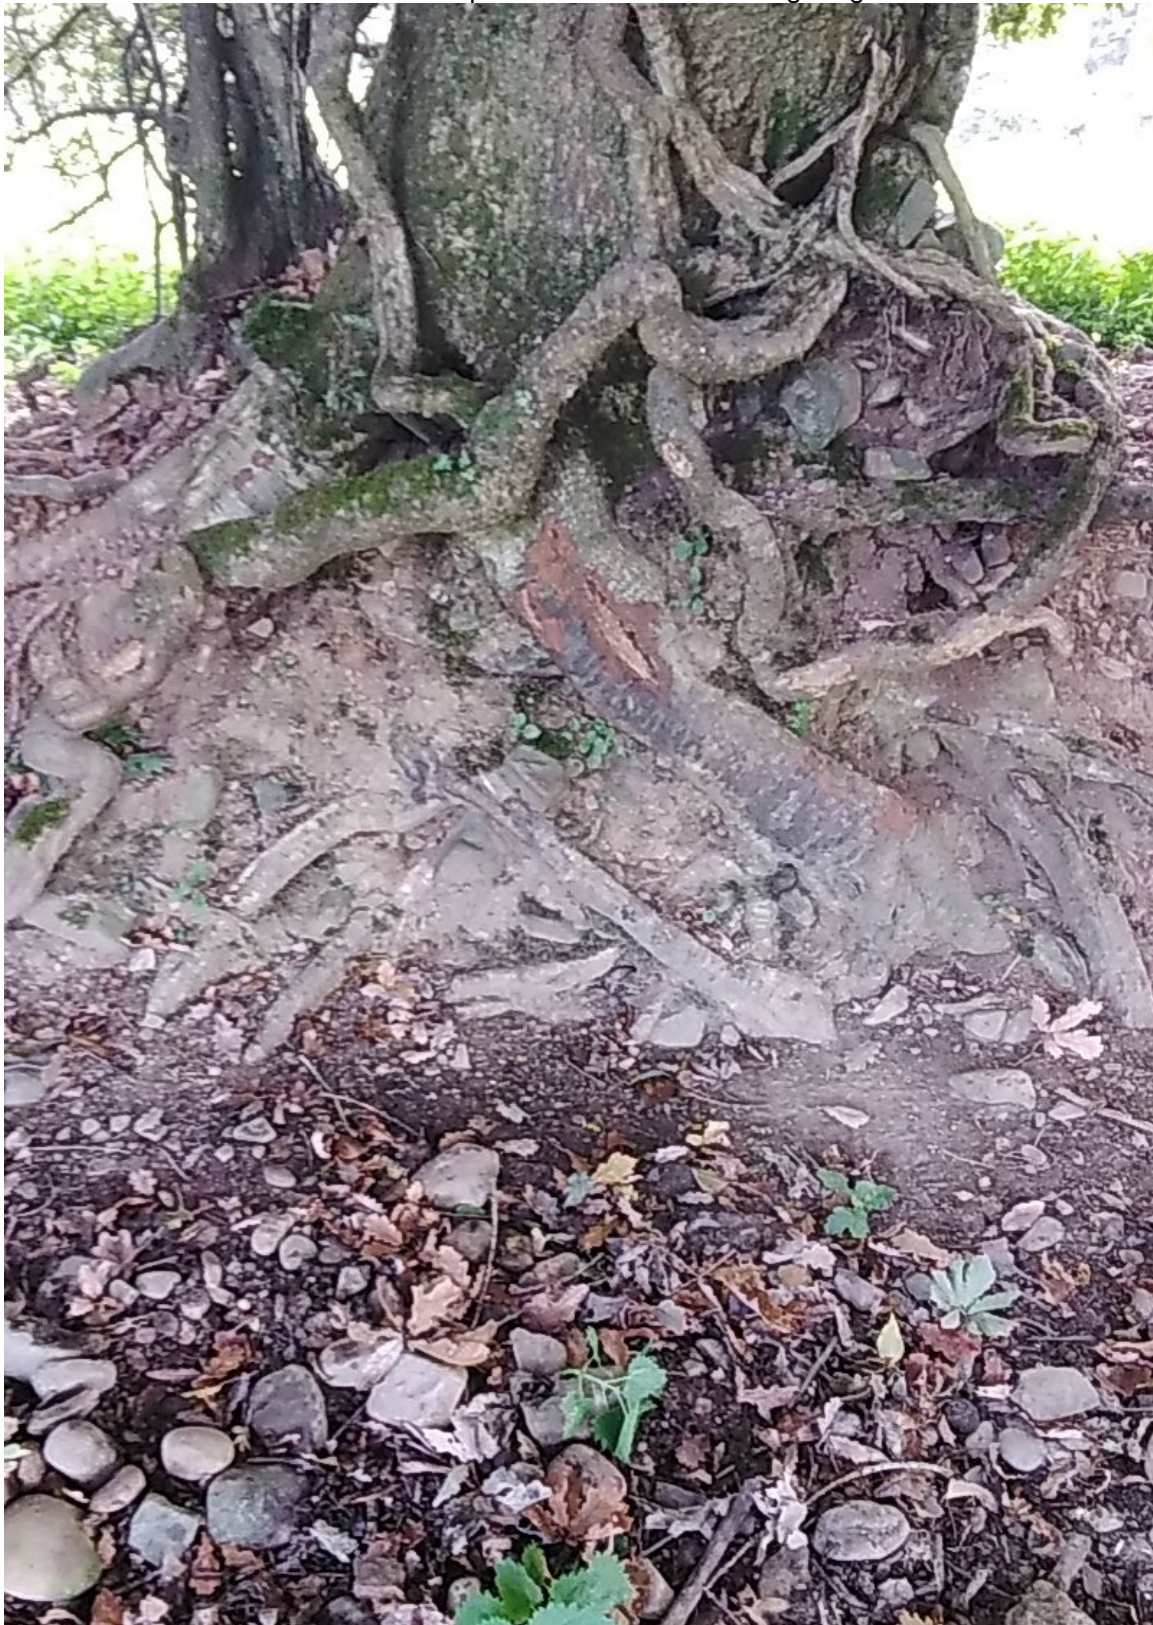
**Photo 5:** T3 Exposed roots due to livestock grazing.
