# **Trueform Ltd**

## **Phase 2 Ground Investigation**

**Begelly Park Gardens  
Kilgetty  
Pembrokeshire  
SA68 0YH**

**Report No: 13.10.028b  
July 2023**

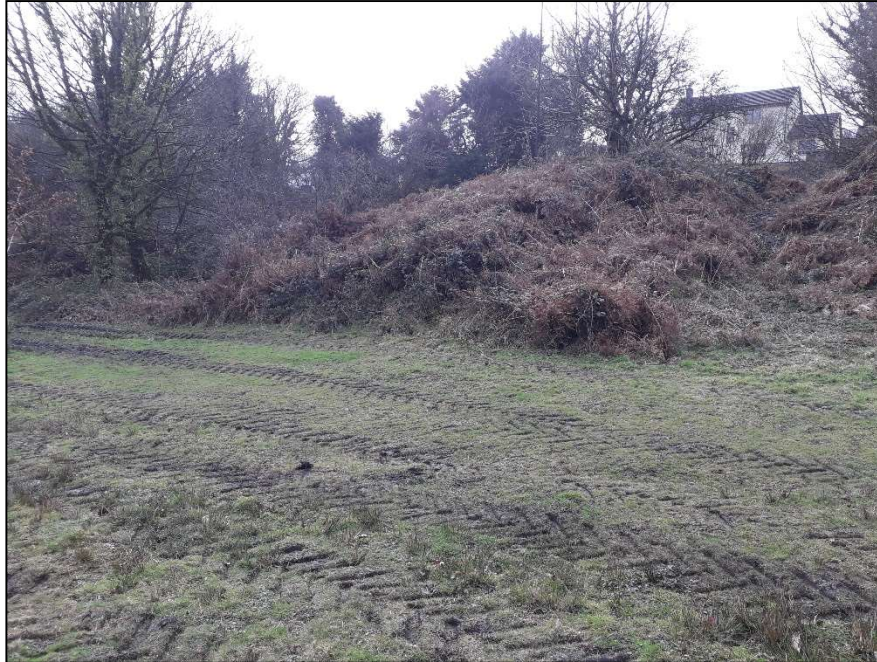
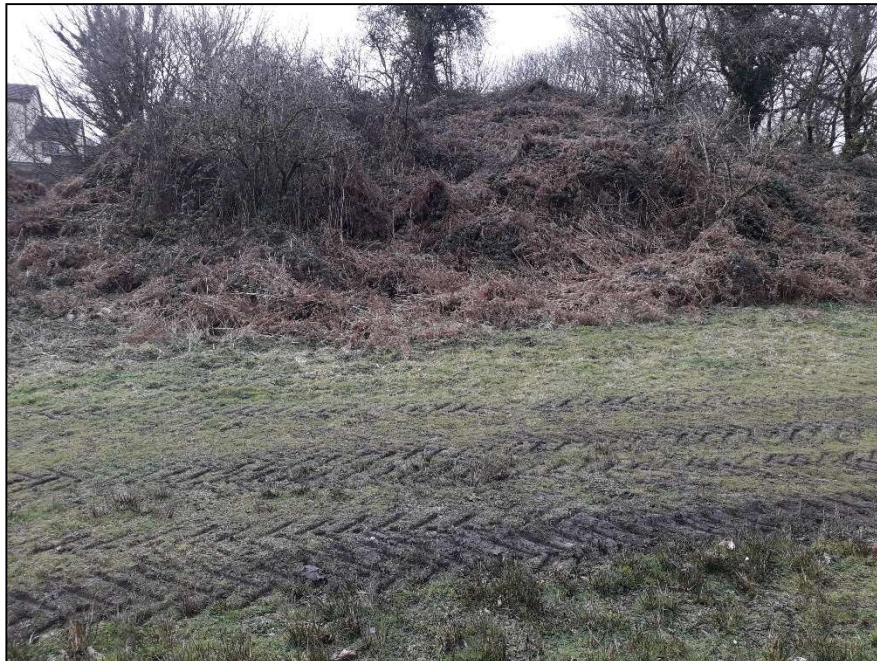
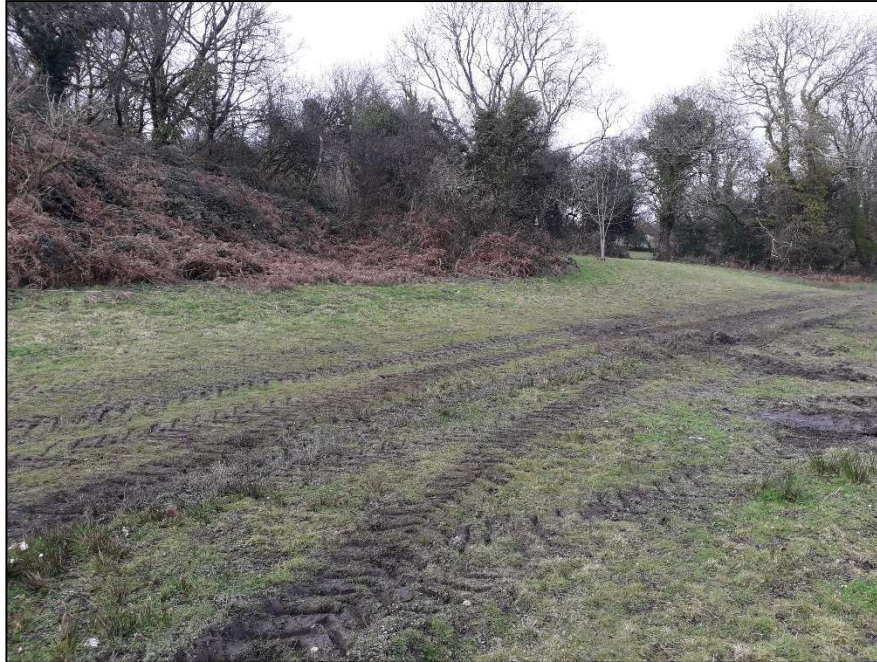
Mounds in the central western area

Two vegetated mounds were noted close to the western site boundary and anecdotal evidence suggested these were formed by arisings from mining in the area.
