## **Water Vole Survey Report:**

Watercourse and lake at  
Park Gardens,  
Begelly,  
Pembrokeshire,  
SA68 0AA

**May 2025**

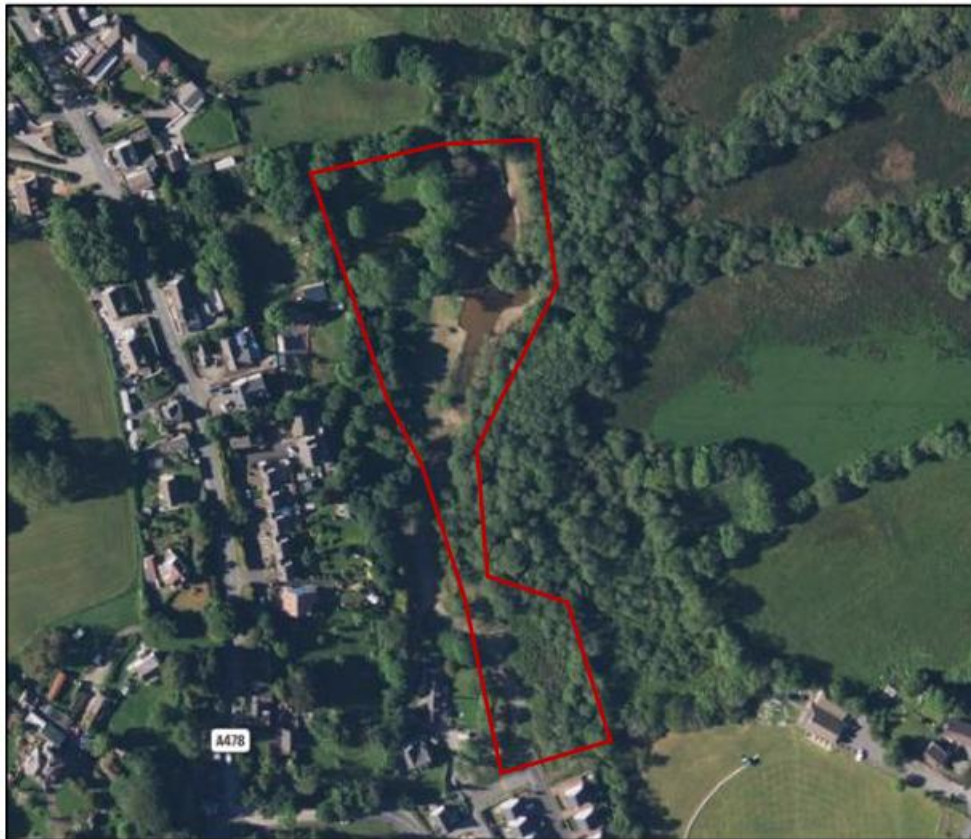
Figure 1. Aerial image of the site with the approximate site boundary is shown in red. (from Apple® Maps).

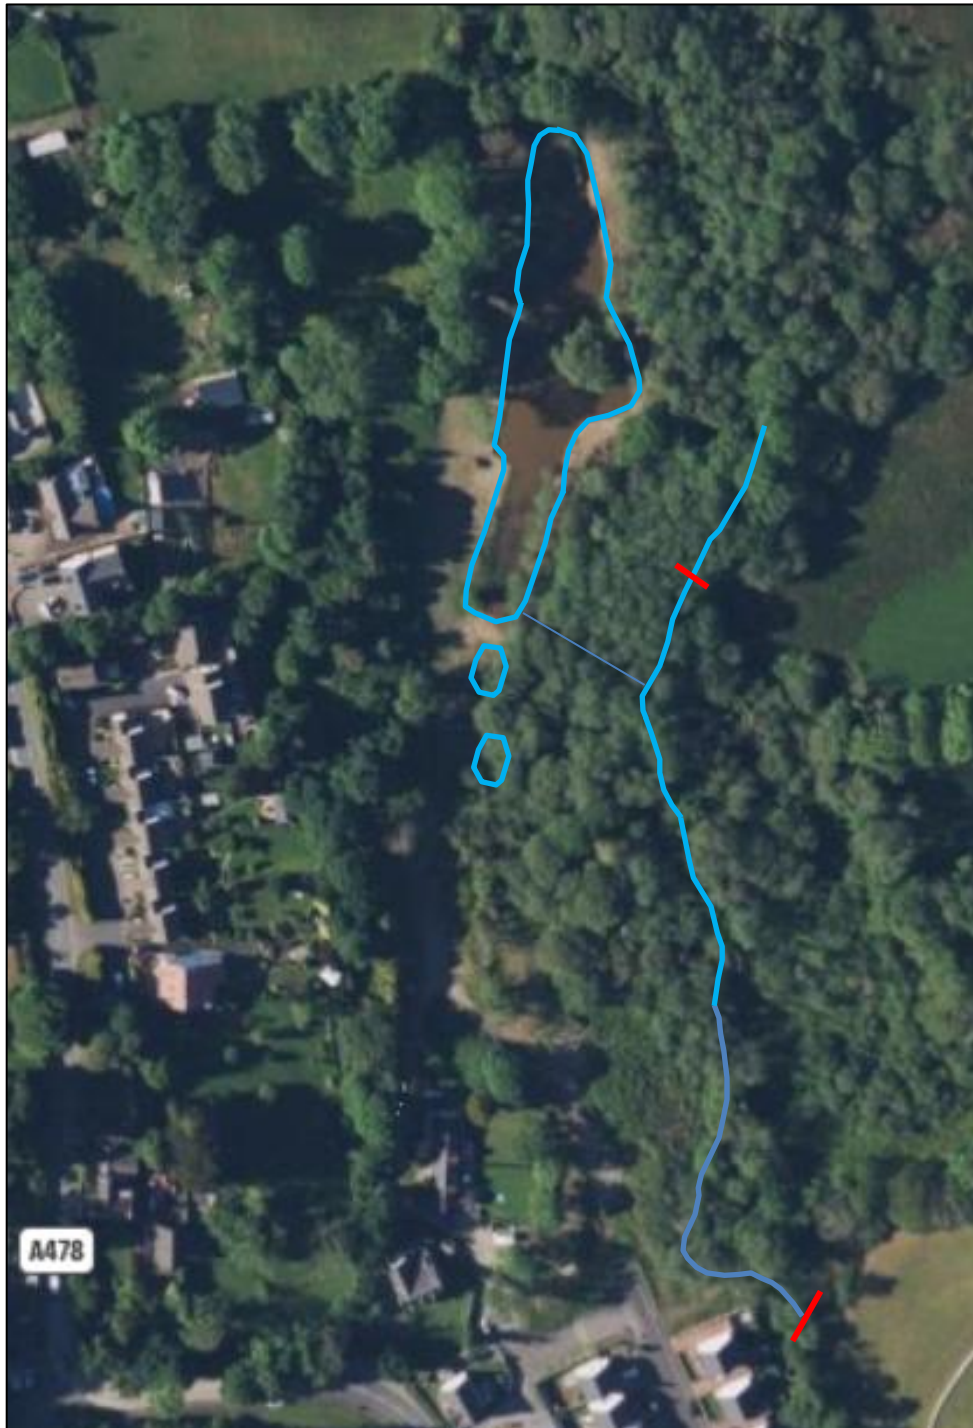
The un-named stream was surveyed from the downstream point where it exits the development boundary (SN 12002 07374) to a point above the outlet from the lake (SN 12006 07604) where ground conditions prevented further access. The entire edge of the lake and the minor waterbodies at the southern end were also surveyed. The survey was conducted during the optimal survey period, in a period of settled, mild weather.

Figure 2. Area surveyed (Google)

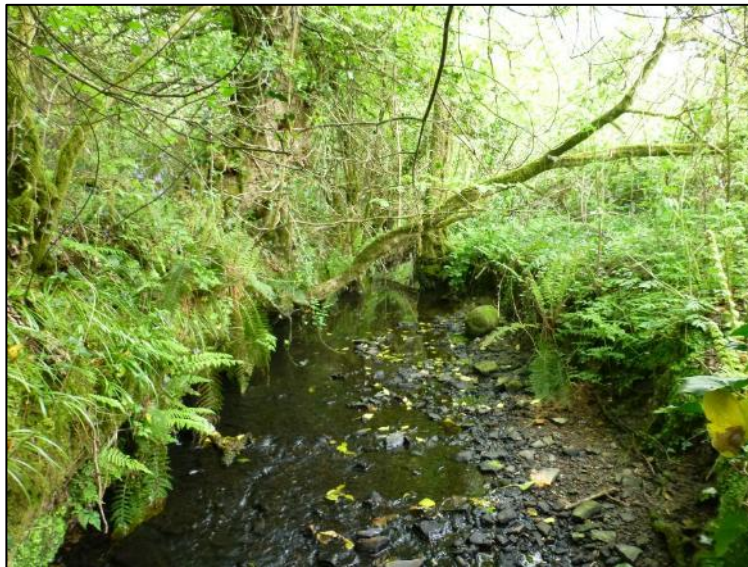
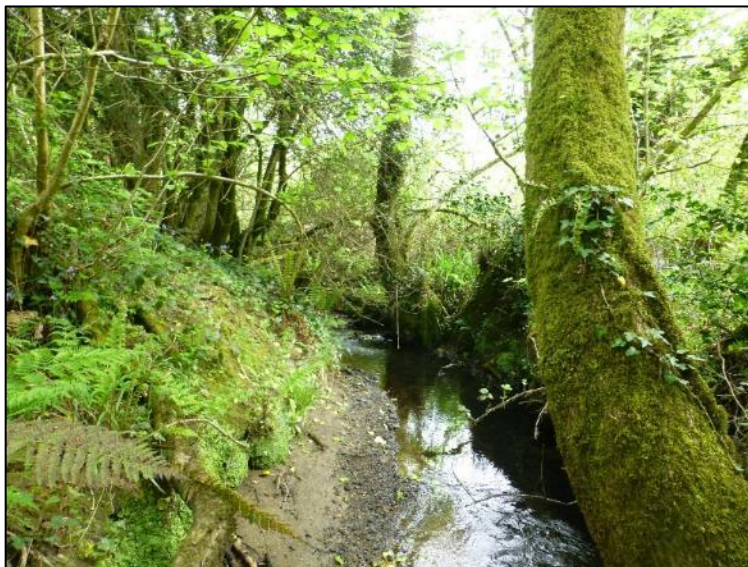
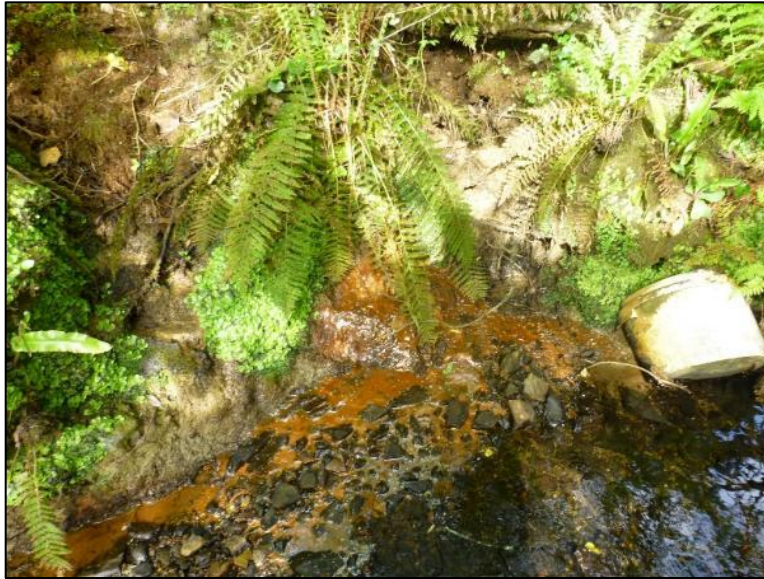
The stream flows through dense wet woodland and is heavily shaded. Channel width varies between 1 and 1.5m, depths are mainly shallow with occasional pools. Channel bed is composed of fine gravels and occasional pebbles. Banks are composed of clay and profiles and heights are good, but poorly vegetated due to shading. Habitat is ideal for mink. No signs of water vole were observed in this section. This reach would allow for water vole to disperse but provides **negligible** habitat (Fig. 5 - 7).

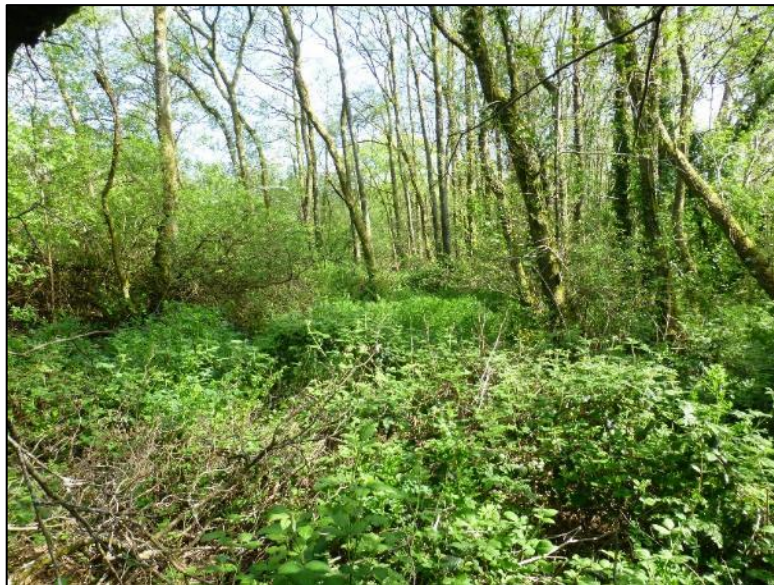
Fig. 8

A shallow seepage/ditch connects the stream to the lake, flowing through shaded woodland with an understory of bramble, nettle and hemlock water-dropwort (Fig. 8)

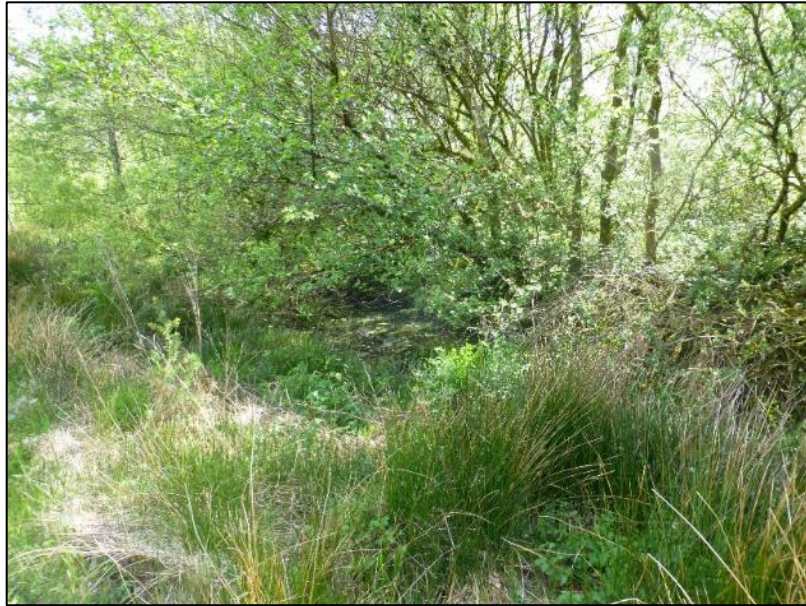
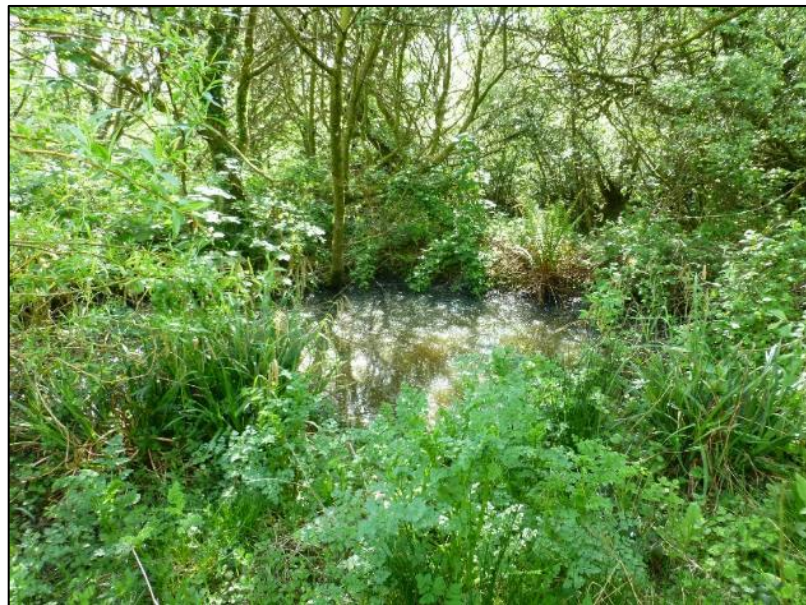
Two seasonal waterbodies are present immediately south of the lake. These are heavily sedimented, shallow, shaded and with no banks for burrowing. They may provide limited foraging opportunities but their habitat value is **negligible** (Figs 9-10).

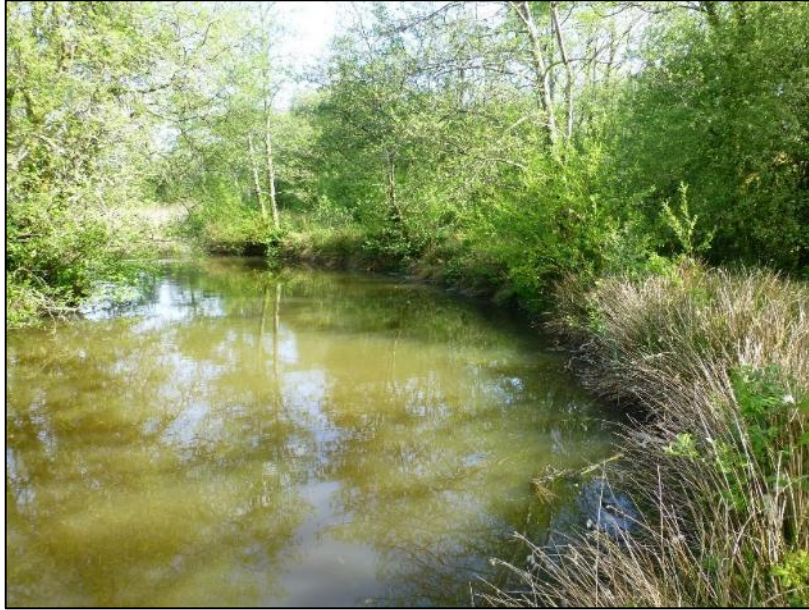
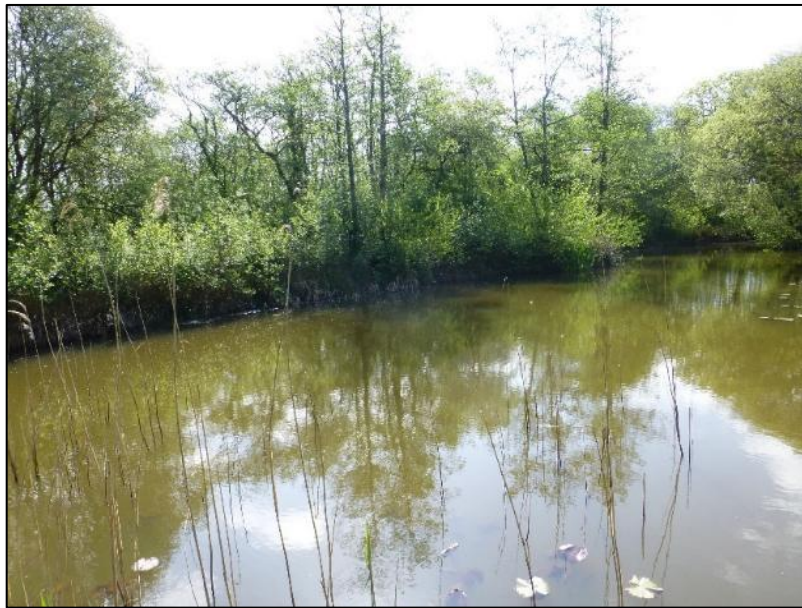
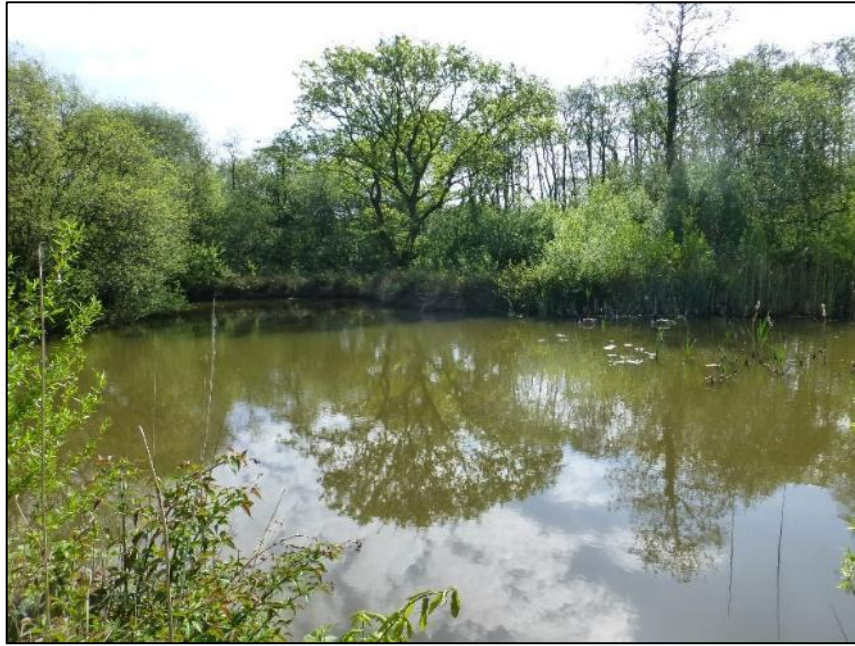
The eastern bank of the lake provides good burrowing opportunities for water vole with relatively steep clay banks and a good uplift above water levels. Water depths are good. The bankside vegetation is dominated by soft rush, providing good cover but poor feeding opportunities. Marginal vegetation is poor, restricted to blocks of reedmace, and the top of bank is previously mown and open. Shading from the adjacent woodland and bankside trees further reduces the habitat value for water vole. No signs of water vole were observed in this section. This section of the lake provides **suitable but poor** water vole habitat (Fig. 11-13).

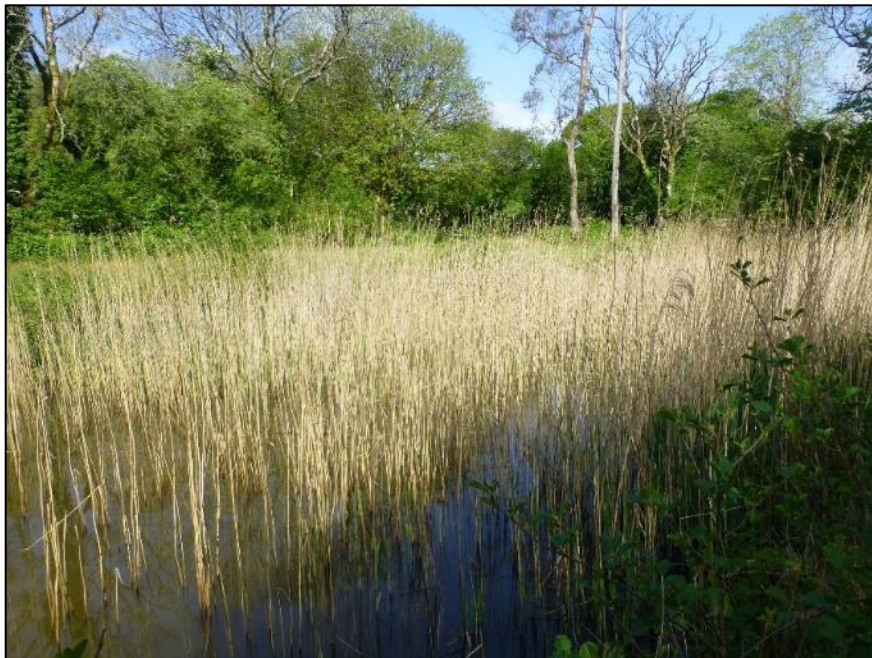
**Fig.14**

At the top end of the lake is an area of reedbed. This would provide suitable areas to forage, but is relatively open and would provide a low degree of cover from predators. No evidence of water vole was observed, and this area would provide **suitable but poor** water vole habitat (Fig.14).

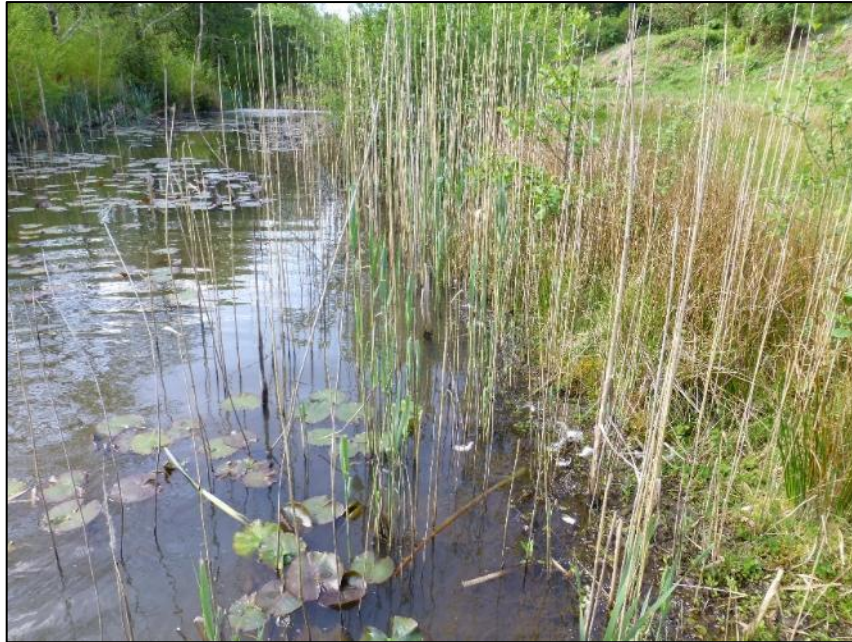
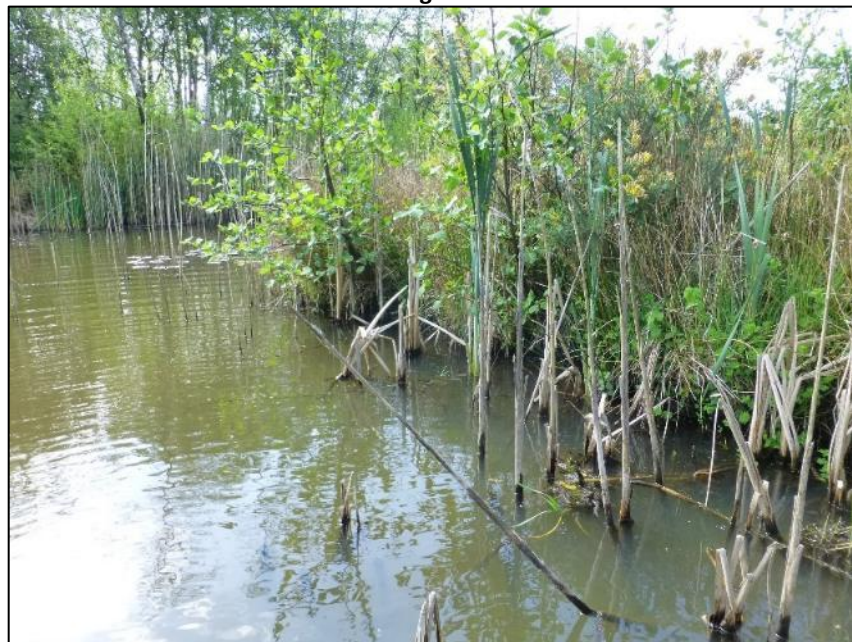
The western lake shore has a shallower profile with little uplift of bank above water level making burrowing opportunities limited. Marginal vegetation is more diverse with reed and reedmace fringing the bank edge. Bankside vegetation is more palatable

but is grazed by Canada geese, and has been mown in a strip beyond the bank edge providing low cover. No evidence of water vole was observed, and this area would provide **suitable but poor** water vole habitat (Fig.15-16).
