# 48 STATION ROAD, PORT TALBOT PRELIMINARY ROOST ASSESSMENT FOR BATS

Date: **September 2025**

| <b>TITLE:</b> | Preliminary Roost Assessment for Bats |

| <b>REPORT No.:</b> | 348-02-01.R2 |

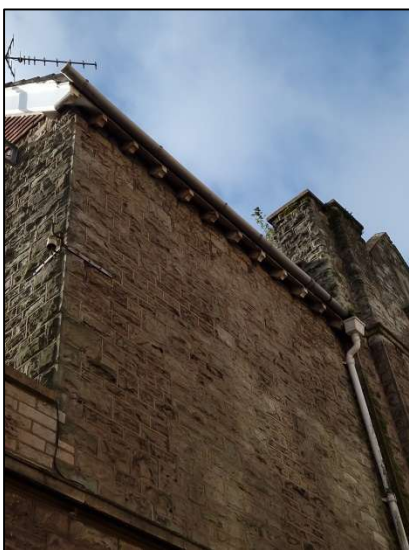
**Figure 12 - 14 (from left to right) – Figure 12: Underside of Northern Gable, Showing Extent of Rafters which make up the Roof in this Location; Figure 13: Wooden Fascia Boards in Excellent Condition, with no Suitable Gaps for Crevice-dwelling Bats being Observed; Figure 11: Ventilation Grilles and Stone Lintel on Northern Gable of Building**

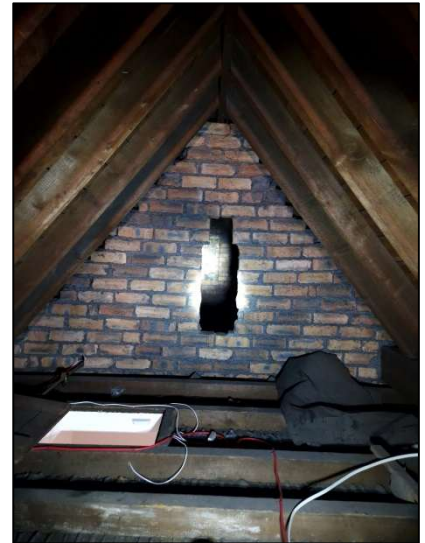
**Figure 32 – Brick Wall Present Halfway along Loft, Dividing the Loft into Distinct Northern / Southern Sections**

A number of timber purlins and rafters present within the loft were identified to be potentially suitable for free-hanging bats, whilst there is also adequate space within the loft which would be suitable for void-dwelling bats.

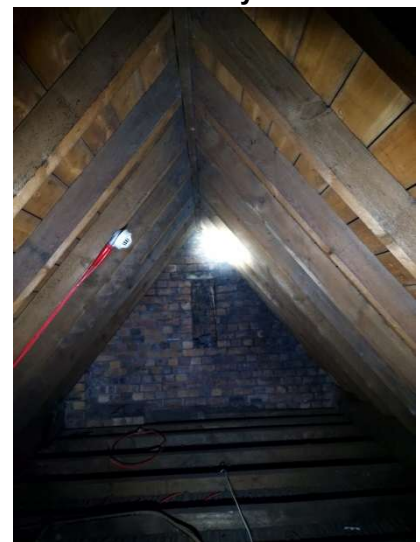
**Figure 35 – Southern Section of Loft, Accessed via Gap, with Brick Wall at Southern Extremity of Loft Visible**

The southern section of the loft meanwhile was much darker than the northern side, owing to the dividing brick wall present halfway along the loft and due to a lack of windows within the southern section of the loft.

This section of the loft is similar in construction to the northern side, and the timber boards underlying the roof tiles were once again observed to be tightly-sealed, with no areas of damage permitting or suitable gaps for crevice-dwelling bats being recorded. The southern extremity of the loft in this location possesses a brick wall, in excellent condition.

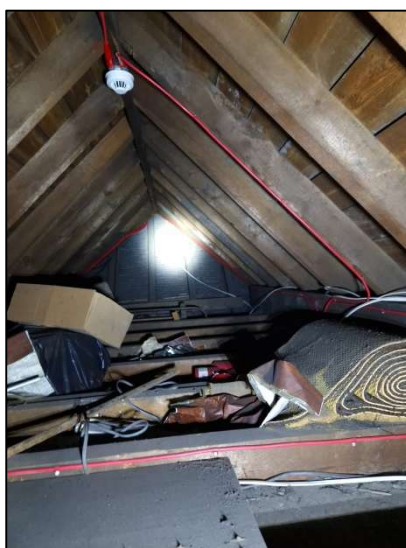
**Figure 37 – Interior Details of 2<sup>nd</sup> Loft within Northern Gable**
