Report No	Date
20105/R1	December 2020
Project	<b>BRYNGELLI, HIRWAUN – GROUND INVESTIGATION REPORT</b>
Client	<b>CB3</b>

<b>Project:</b>
<b>BRYNGELLI, HIRWAUN – GROUND INVESTIGATION REPORT</b>

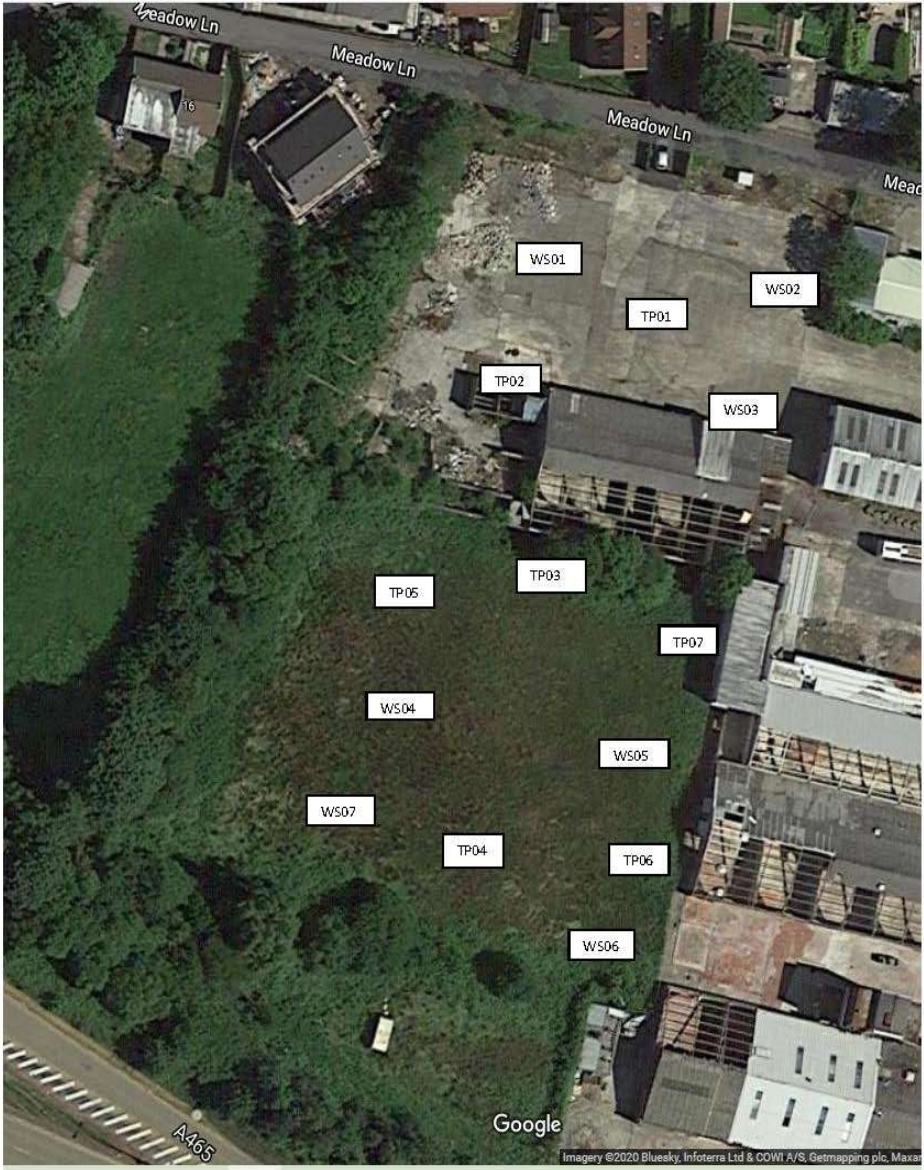
Figure SGS/20105/02

Exploratory Hole Locations	SGS/20105/02
SPT'N' v Depth	SGS/20105/SPT
Atterberg Limits 'A' Line	SGS/20105/ALine

Site works were undertaken on 02 and 03 December 2020 and comprised 7 Trial Pits, 3 Soakaway tests and 7 Window Sample holes. Conditions during the fieldwork were predominantly overcast and inclement. The positions are shown on Drawing SGS/20105/02, Appendix G
